**CONSTRUCTION VIBRATION MONITORING SUMMARY REPORT
DECEMBER 1- DECEMBER 31, 2015**

**VIRGINIA AVENUE TUNNEL RECONSTRUCTION PROJECT
WASHINGTON, DC**

**Prepared for:
CSX Transportation**

**Prepared by:
Gannett Fleming Inc.**

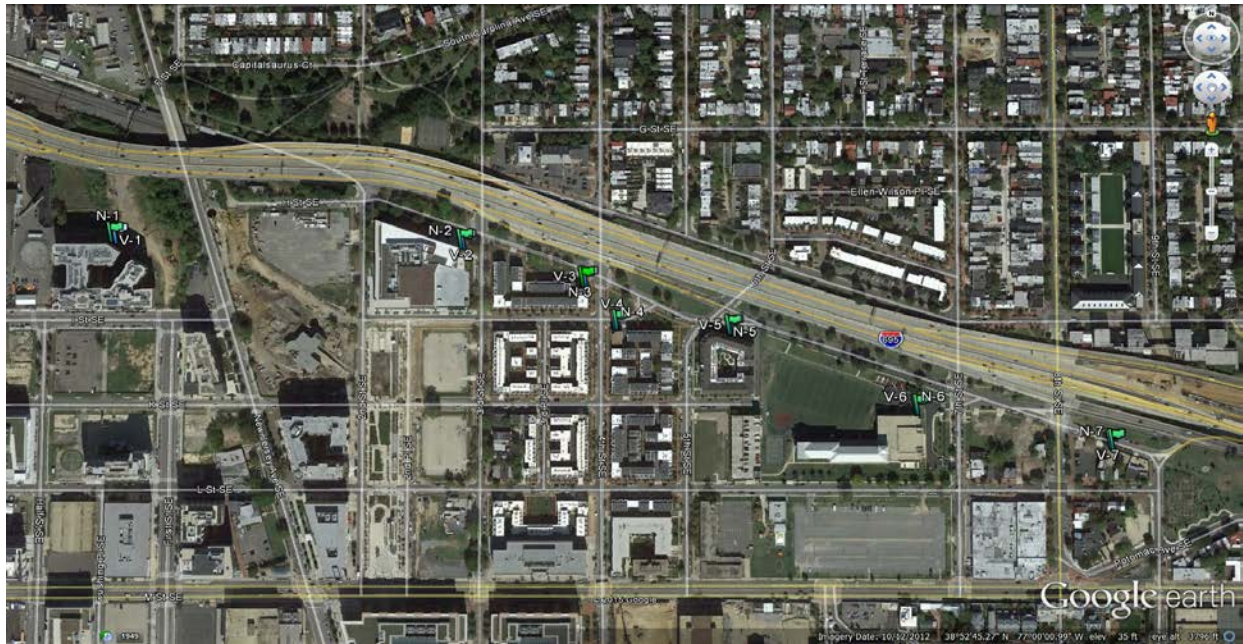
Figure 1. Vibration Monitoring Locations

Construction vibration level data was collected for the reporting period starting December 1 – December 31, 2015. Eight fixed vibration monitoring locations were measured continuously to monitor vibration levels since the beginning of major construction activities in May 2015. Vibration level data was collected every minute for the duration of the vibration monitoring period. The locations of the monitoring stations are depicted in Figure 1 and the addresses described in Table 1.

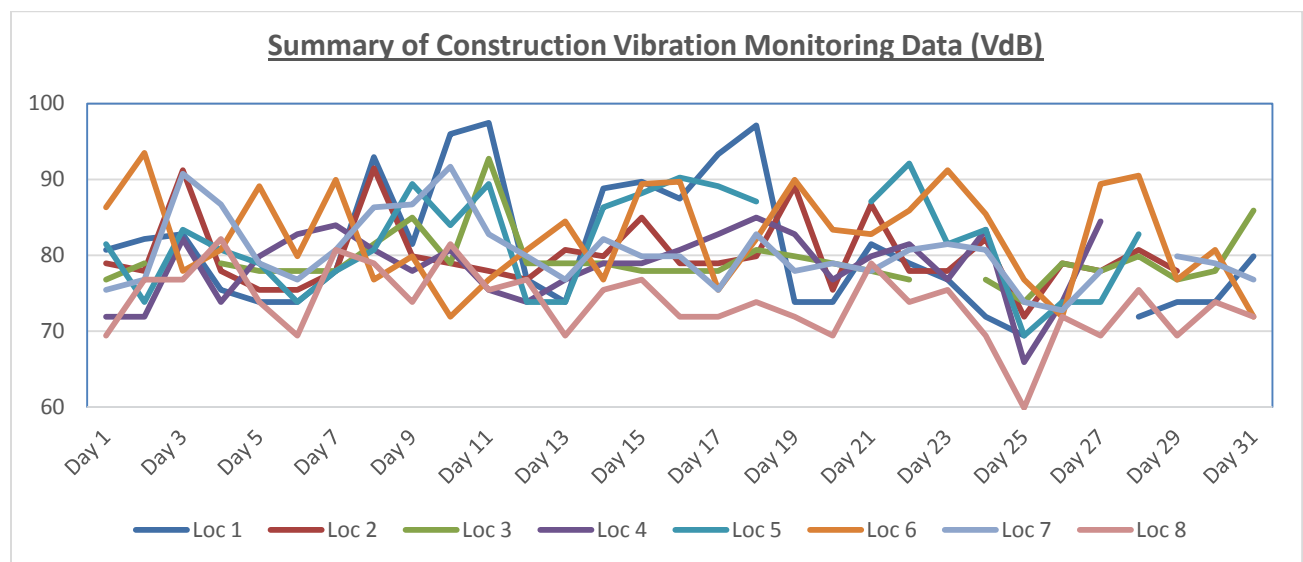
Figure 2. Summary of Construction Vibration Monitoring Data (VdB) – December 2015

Table 2 presents the results of the maximum vibration levels measured during the month of December 2015 and show how the measured levels compare to the established vibration criteria. The average daily vibration level results are plotted in Figure 2. Note that no exceedances occurred during the month of December 2015.
