CONSTRUCTION VIBRATION MONITORING SUMMARY REPORT

SEPTEMBER 1- SEPTEMBER 30, 2015

**VIRGINIA AVENUE TUNNEL RECONSTRUCTION PROJECT
WASHINGTON, DC**

**Prepared by:
Gannett Fleming Inc.**

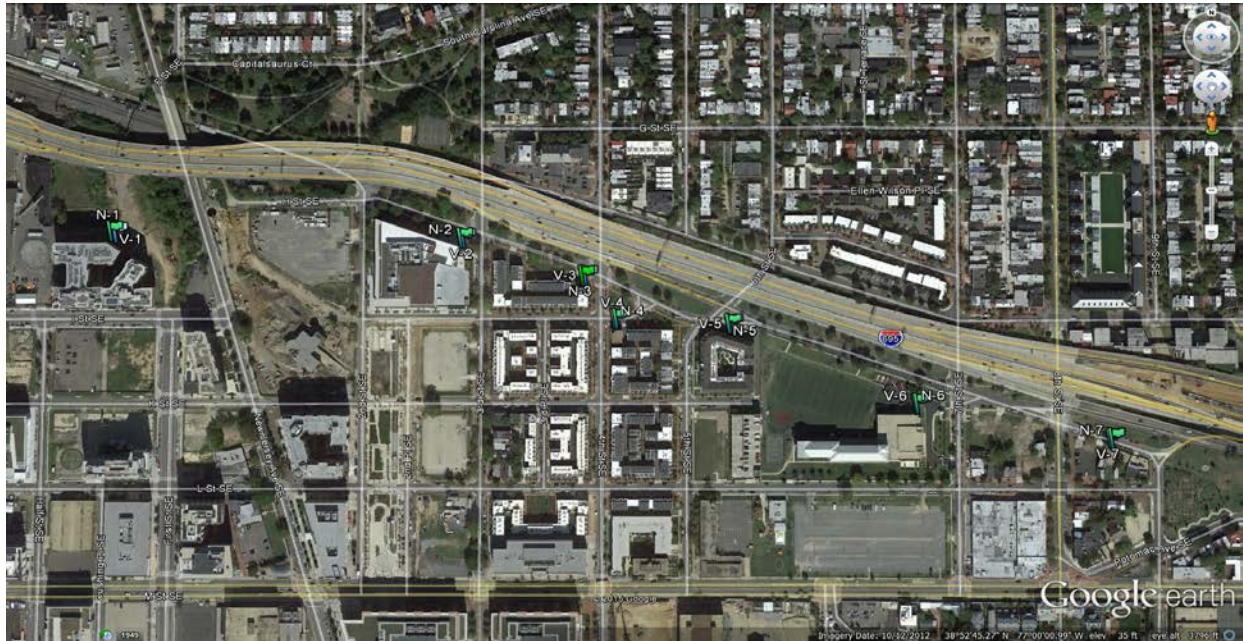
Figure 1. Vibration Monitoring Locations

Construction vibration level data was collected for the reporting period starting September 1 – September 30, 2015. Eight fixed vibration monitoring locations were measured continuously to monitor vibration levels since the beginning of major construction activities in May 2015. Vibration level data was collected every minute for the duration of the vibration monitoring period. The locations of the monitoring stations are depicted in Figure 1 and the addresses described in Table 1.

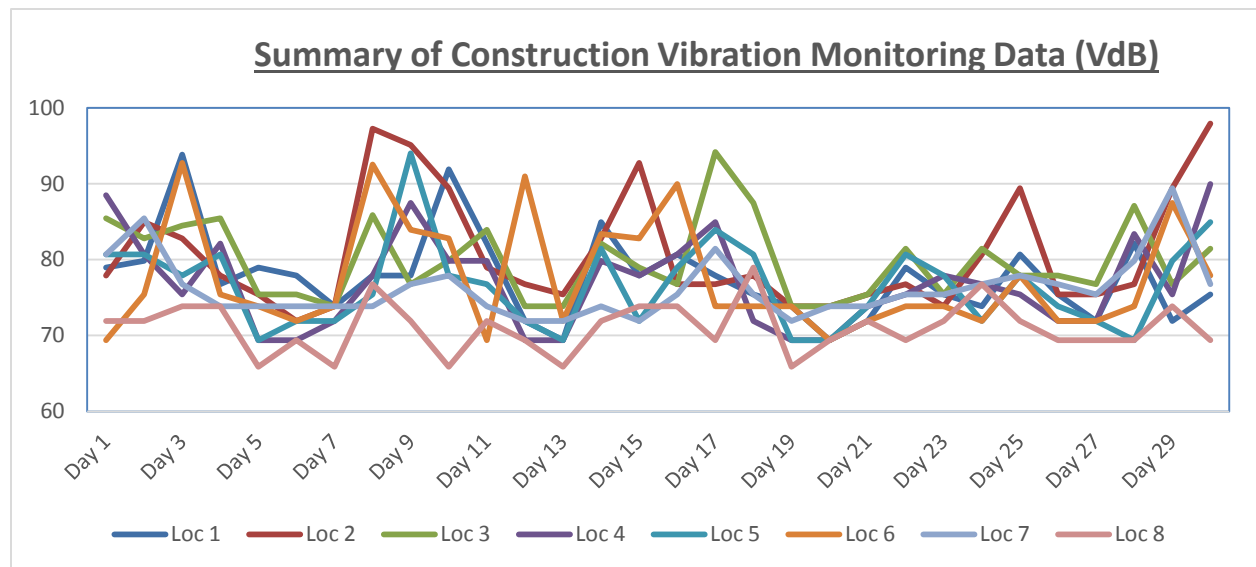
Figure 2. Summary of Construction Vibration Monitoring Data (VdB) – September 2015

Table 2 presents the results of the maximum vibration levels measured during the month of September 2015 and shows how the measured levels compare to the established vibration criteria. The average daily vibration levels are plotted in Figure 2. No exceedances occurred during the month of September.
