CONSTRUCTION VIBRATION MONITORING SUMMARY REPORT

AUGUST 1- AUGUST 31, 2015

**VIRGINIA AVENUE TUNNEL RECONSTRUCTION PROJECT
WASHINGTON, DC**

Construction Vibration Monitoring Summary

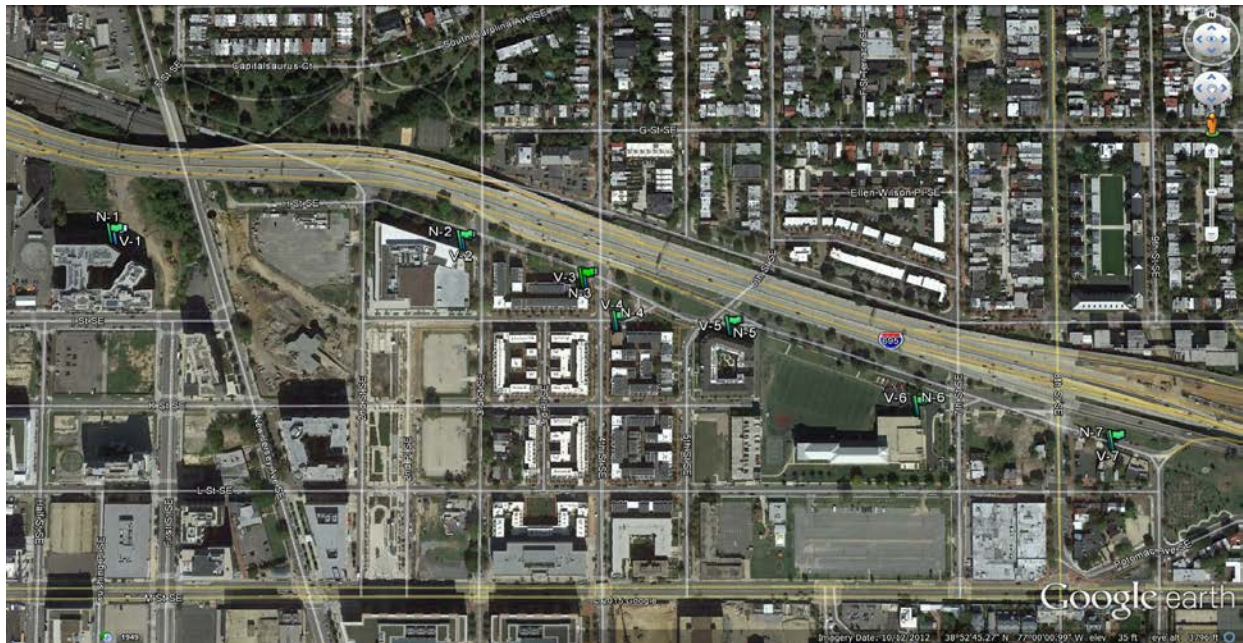
Figure 1. Vibration Monitoring Locations

Construction vibration level data was collected for the reporting period starting August 1 – August 31, 2015. Eight fixed vibration monitoring locations were measured continuously to monitor vibration levels since the beginning of major construction activities in May 2015. Vibration level data was collected every minute for the duration of the vibration monitoring period. The locations of the monitoring stations are depicted in Figure 1 and the addresses described in Table 1.

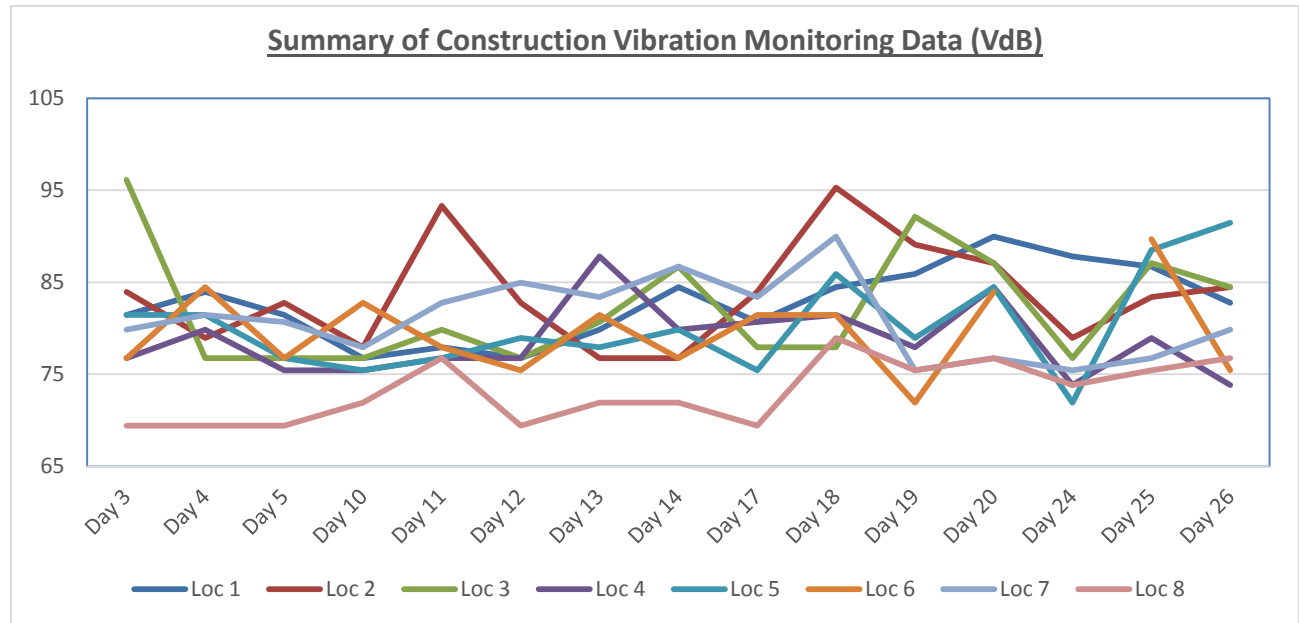
Figure 2. Summary of Construction Vibration Monitoring Data (VdB) – August 2015

Table 2 presents the results of the maximum vibration levels measured during the month of August 2015 and show how the measured levels compare to the established vibration criteria. The average daily vibration level results are plotted in Figure 2.
