# **CONSTRUCTION VIBRATION MONITORING SUMMARY REPORT**

**JUNE 1- JUNE 30, 2015**

**VIRGINIA AVENUE TUNNEL RECONSTRUCTION PROJECT  
WASHINGTON, DC**

## **Construction Vibration Monitoring Summary**

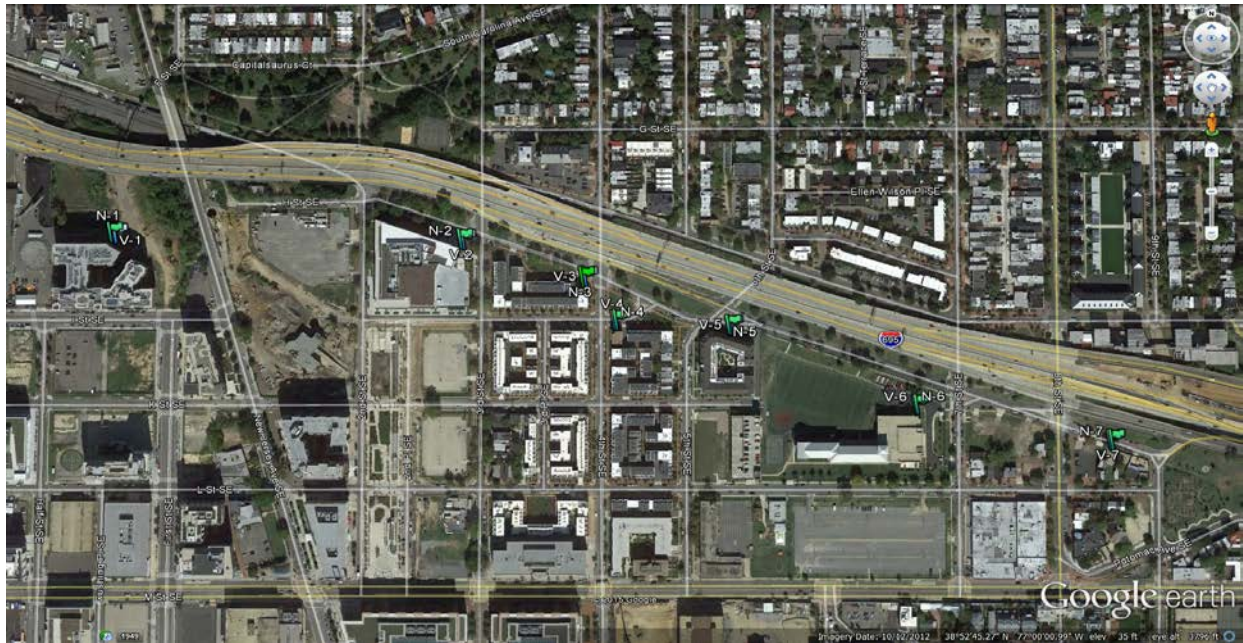
**Figure 1. Vibration Monitoring Locations**

Construction vibration level data was collected starting June 1, 2015. Eight fixed vibration monitoring locations were measured continuously to monitor vibration levels since the beginning of June. Vibration level data was collected every minute for the duration of the vibration monitoring period. The locations of the monitoring stations are depicted in Figure 1 and the addresses described in Table 1.

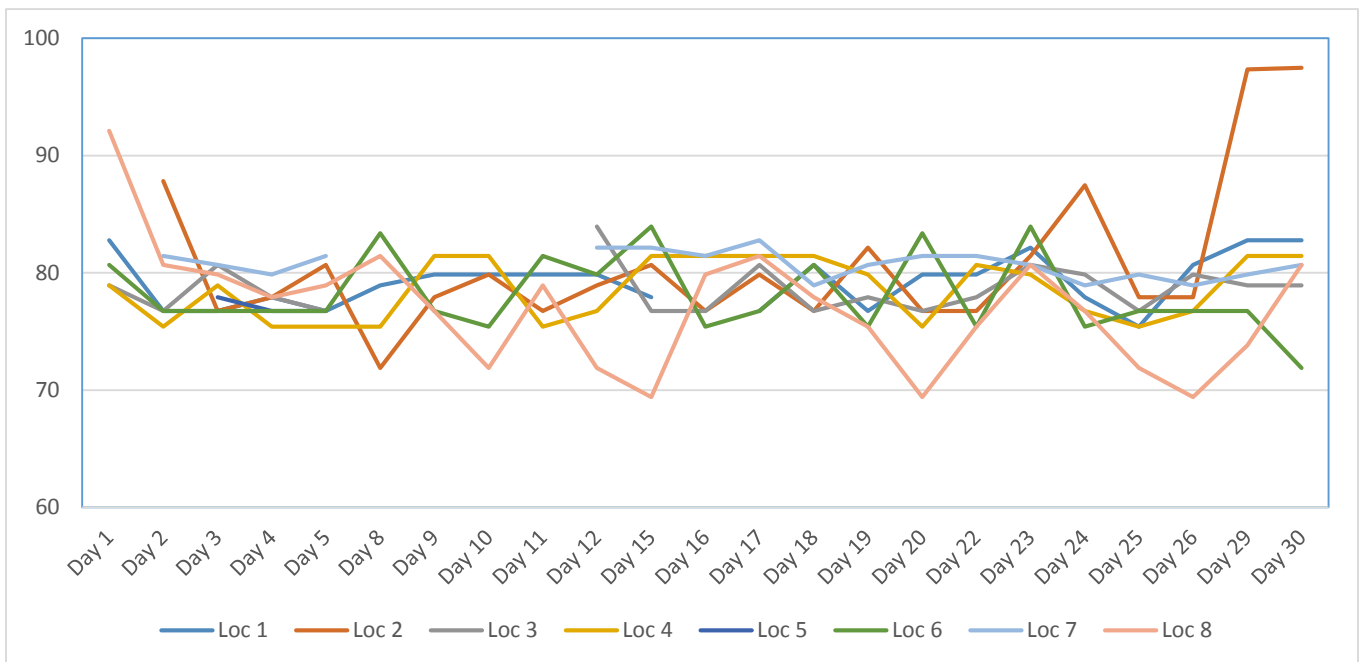
**Figure 2. Summary of Construction Vibration Monitoring Data (VdB) – June 2015**

Table 2 presents the results of the maximum vibration levels measured during the month of June 2015 and show how the measured levels compare to the established vibration criteria. The average daily vibration level results are plotted in Figure 2.
