CONSTRUCTION VIBRATION MONITORING SUMMARY REPORT

APRIL 1 - APRIL 30, 2016

**VIRGINIA AVENUE TUNNEL RECONSTRUCTION PROJECT
WASHINGTON, DC**

**Prepared by:
Gannett Fleming Inc.**

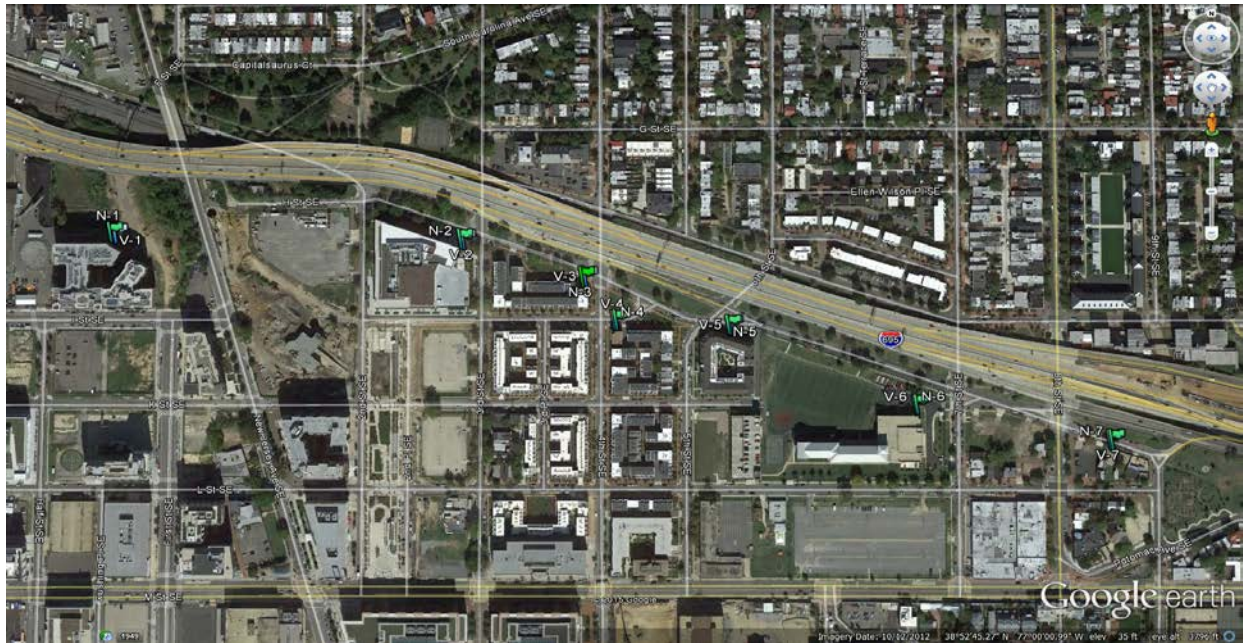
Figure 1. Vibration Monitoring Locations

Construction vibration level data was collected for the reporting period starting April 1 through April 30, 2016. Eight fixed vibration monitoring locations were measured continuously to monitor vibration levels since the beginning of major construction activities in May 2015. Vibration level data was collected every minute for the duration of the vibration monitoring period. The locations of the monitoring stations are depicted in Figure 1 and the addresses described in Table 1.

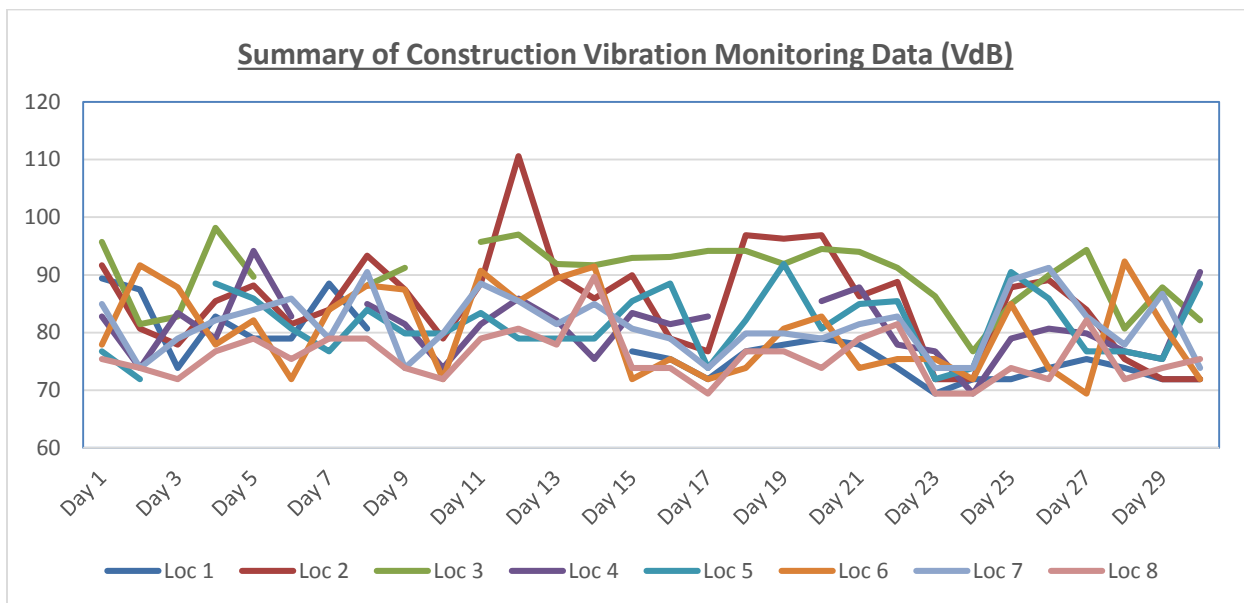
Figure 2. Summary of Construction Vibration Monitoring Data (VdB) – April 2016

Table 2 presents the results of the maximum vibration levels measured during the month of April 2016 and show how the measured levels compare to the established vibration criteria. The average daily vibration level results are plotted in Figure 2. An exceedance of the vibration criteria was recorded during construction and pile drilling activities at Locations 2 and 4. However, the infrequent rate of occurrence (two times during the month) and the short duration of the events (1 to 3 seconds) are not expected to cause damage to any of the nearby structures at Locations 2 and 4.
