CONSTRUCTION VIBRATION MONITORING SUMMARY REPORT

JUNE 1 - JUNE 30, 2016

**VIRGINIA AVENUE TUNNEL RECONSTRUCTION PROJECT
WASHINGTON, DC**

**Prepared by:
Gannett Fleming Inc.**

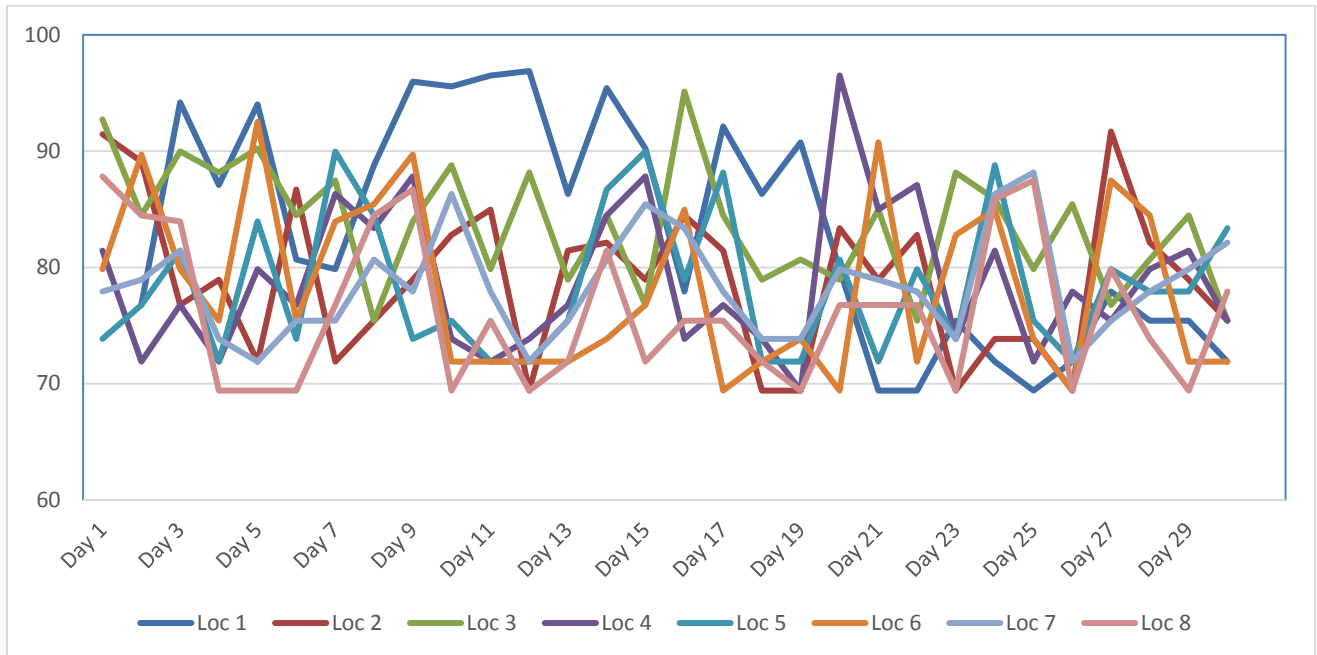
Figure 2. Summary of Construction Vibration Monitoring Data (VdB) – June 2016

Table 2 presents the results of the maximum vibration levels measured during the month of June 2016 and show how the measured levels compare to the established vibration criteria. The average daily vibration level results are plotted in Figure 2. An exceedance of the vibration criteria was recorded during construction at Location 4. However, the infrequent rate of occurrence (once during the month) and the short duration of the event (3 seconds) is not expected to cause damage to any of the nearby structures at Location 4. [Note that Location 1 did not record data on June 1 due to power loss.]
