**CONSTRUCTION VIBRATION MONITORING SUMMARY REPORT**

**MARCH 1- MARCH 31, 2016**

**VIRGINIA AVENUE TUNNEL RECONSTRUCTION PROJECT  
WASHINGTON, DC**

**Prepared by:  
Gannett Fleming Inc.**

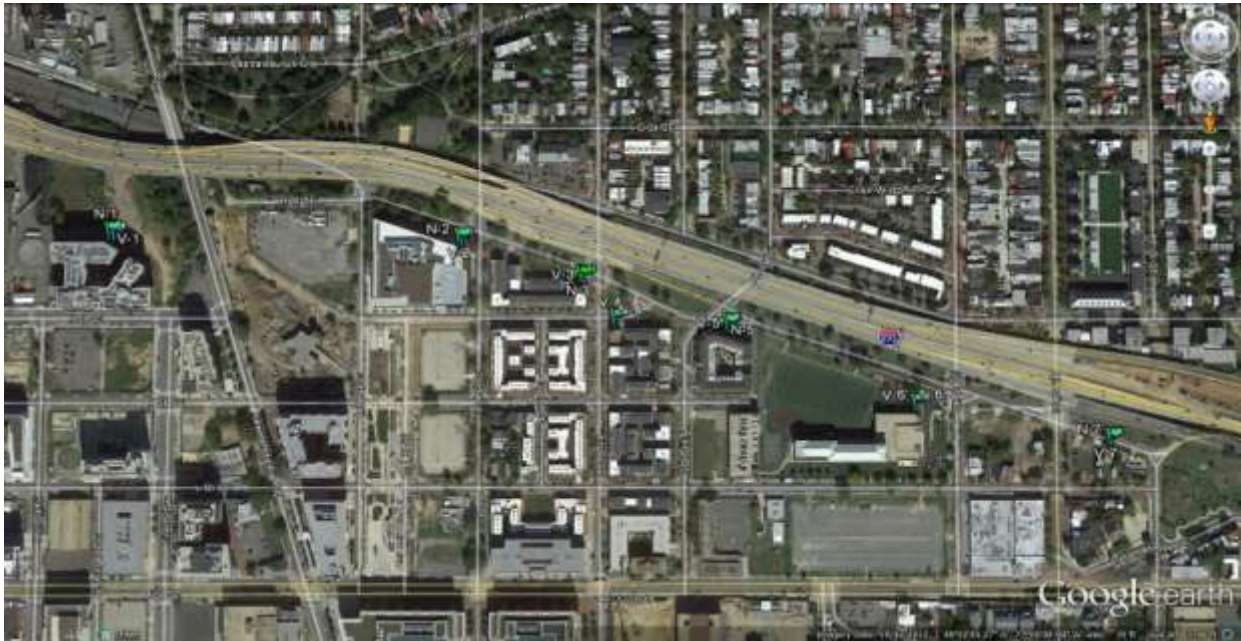
**Figure 1. Vibration Monitoring Locations**

Construction vibration level data was collected for the reporting period starting March 1 through March 31, 2016. Eight fixed vibration monitoring locations have been measured continuously to monitor vibration levels since the beginning of major construction activities in May 2015. Vibration level data was collected every minute for the duration of the vibration monitoring period. The locations of the monitoring stations are depicted in Figure 1 and the addresses described in Table 1.

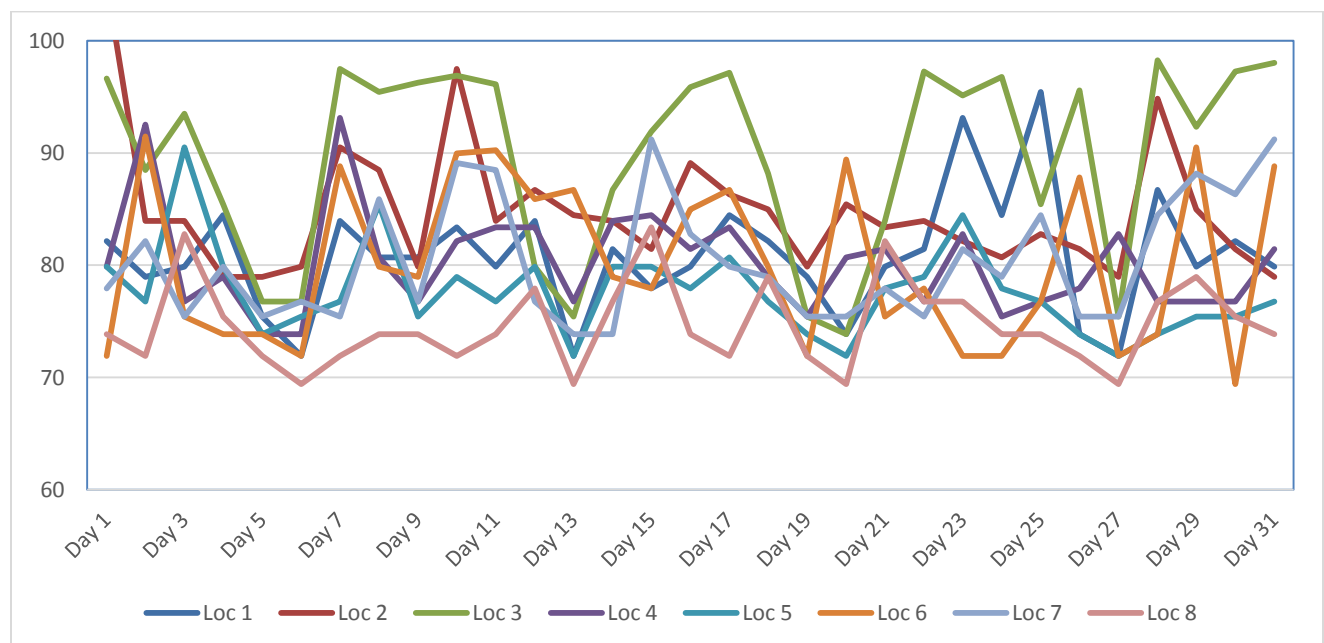
**Figure 2. Summary of Construction Vibration Monitoring Data (VdB) – March 2016**

Table 2 presents the results of the maximum vibration levels measured during the month of March 2016 and shows how the measured levels compare to the established vibration criteria. The average daily vibration level results are plotted in Figure 2. An exceedance of the vibration criteria was recorded during construction and pile drilling activities at Locations V2 and V4. However, the infrequent rate of occurrence (two times during the month) and the short duration of the events (1 to 3 seconds) are not expected to cause damage to any of the nearby structures at Locations V2 and V4.
