CONSTRUCTION VIBRATION MONITORING SUMMARY REPORT

MAY 1 - MAY 31, 2016

**VIRGINIA AVENUE TUNNEL RECONSTRUCTION PROJECT
WASHINGTON, DC**

**Prepared by:
Gannett Fleming Inc.**

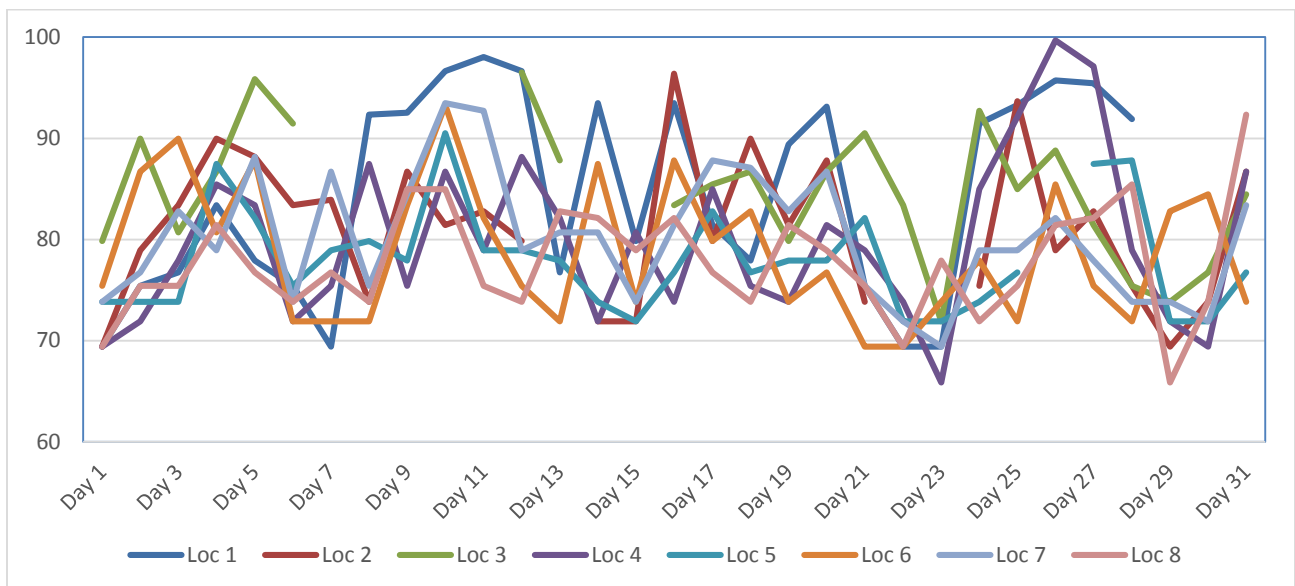
Figure 2. Summary of Construction Vibration Monitoring Data (VdB) – May 2016

Table 2 presents the results of the maximum vibration levels measured during the month of May 2016 and shows how the measured levels compare to the established vibration criteria. The average daily vibration level results are plotted in Figure 2. An exceedance of the vibration criteria was recorded during construction and pile drilling activities at Location 4. However, the infrequent rate of occurrence (three times during the month) and the short duration of the events (3 seconds) are not expected to cause damage to any of the nearby structures at Location 4.
