CONSTRUCTION VIBRATION MONITORING SUMMARY REPORT

NOVEMBER 1 - NOVEMBER 30, 2016

**VIRGINIA AVENUE TUNNEL RECONSTRUCTION PROJECT
WASHINGTON, DC**

**Prepared by:
Gannett Fleming Inc.**

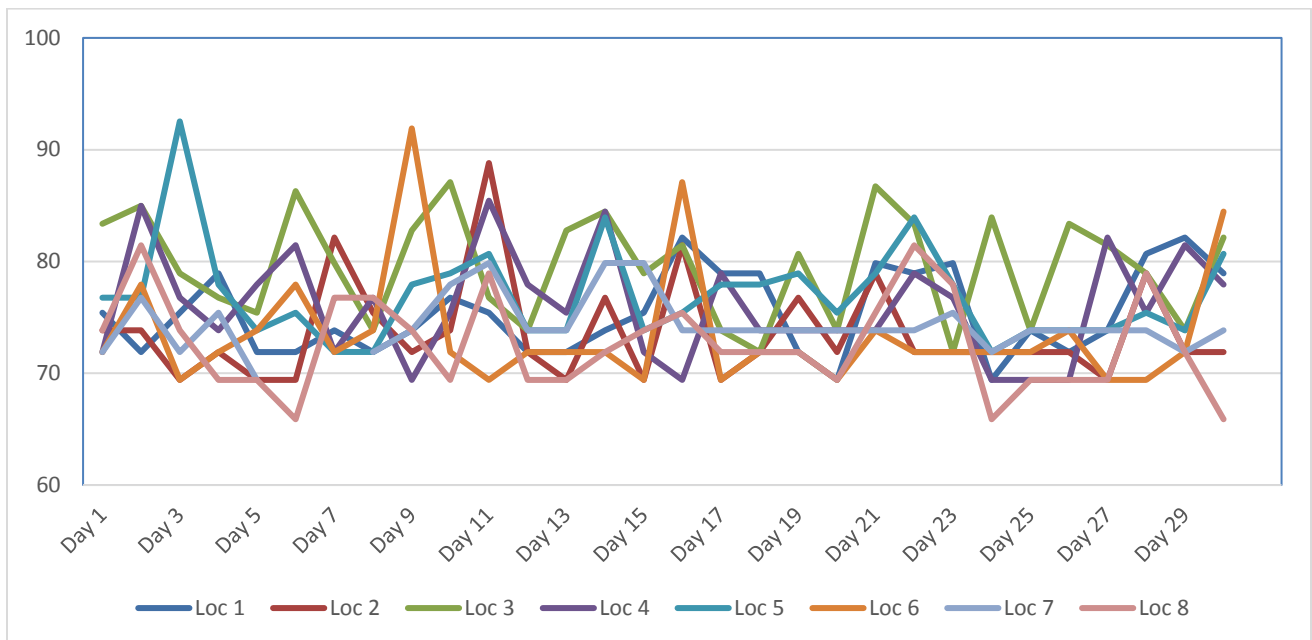
Figure 2. Summary of Construction Vibration Monitoring Data (VdB) – November 2016

Table 2 presents the results of the maximum vibration levels measured during the month of November 2016 and show how the measured levels compare to the established vibration criteria. The average daily vibration level results are plotted in Figure 2. There was no exceedance of the vibration criteria that was recorded during construction. [Note that Location V7 did not record data on November 6 and 7 due to power losses and equipment maintenance.]
