CONSTRUCTION VIBRATION MONITORING SUMMARY REPORT

SEPTEMBER 1 - SEPTEMBER 30, 2016

**VIRGINIA AVENUE TUNNEL RECONSTRUCTION PROJECT
WASHINGTON, DC**

**Prepared by:
Gannett Fleming Inc.**

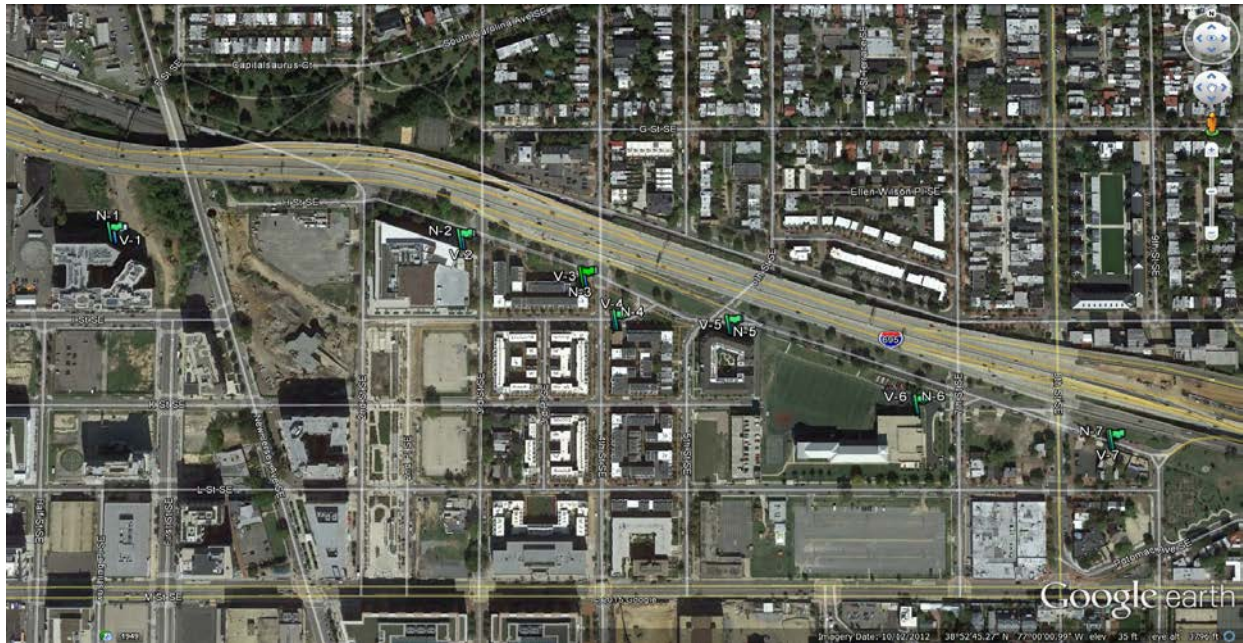
Figure 1. Vibration Monitoring Locations

Construction vibration level data was collected for the reporting period starting September 1 through September 30, 2016. Eight fixed vibration monitoring locations have been measured continuously to monitor vibration levels since the beginning of major construction activities in May 2015. Vibration level data was collected every minute for the duration of the vibration monitoring period. The locations of the monitoring stations are depicted in Figure 1 and the addresses described in Table 1.

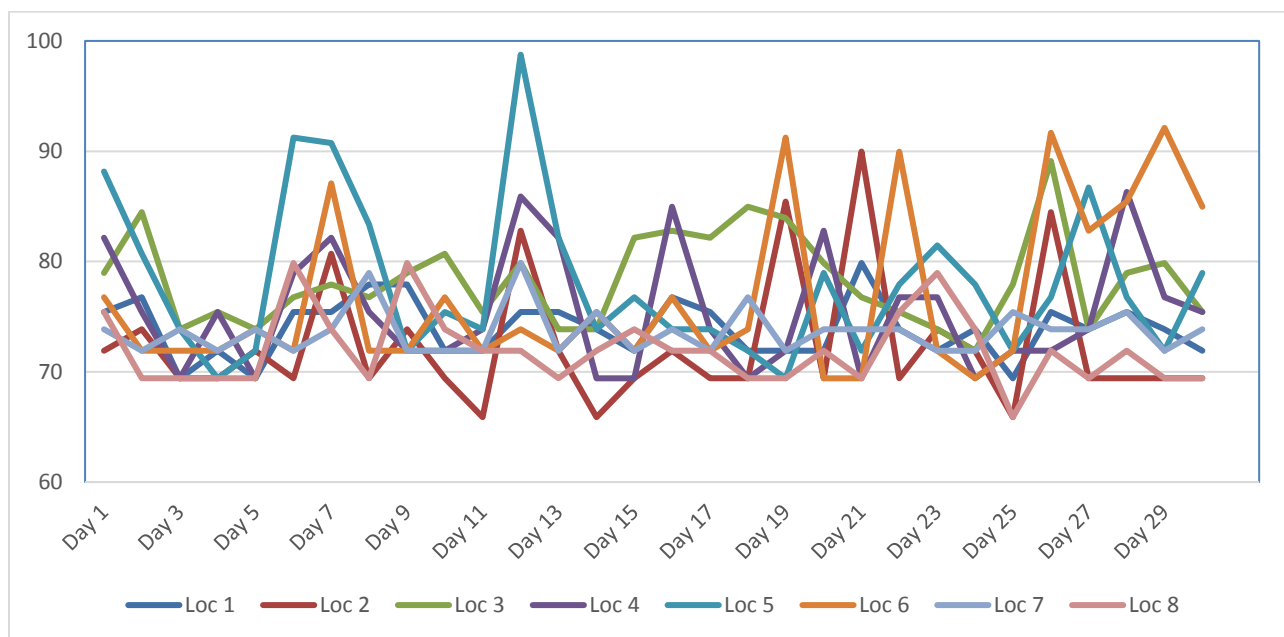
Figure 2. Summary of Construction Vibration Monitoring Data (VdB) – September 2016

Table 2 presents the results of the maximum vibration levels measured during the month of September 2016 and shows how the measured levels compare to the established vibration criteria. The average daily vibration level results are plotted in Figure 2. An exceedance of the vibration criteria was recorded on September 12th during construction activities near Monitoring Location 5. However, the limited occurrence (two events during a 2-hour period) and the short duration of the event (less than 3 seconds each) is not expected to cause damage to any of the nearby structures at this location.
