CONSTRUCTION VIBRATION MONITORING SUMMARY REPORT

VIRGINIA AVENUE TUNNEL RECONSTRUCTION PROJECT WASHINGTON, DC

AUGUST 1 - AUGUST 31, 2016

Prepared by: Gannett Fleming Inc.

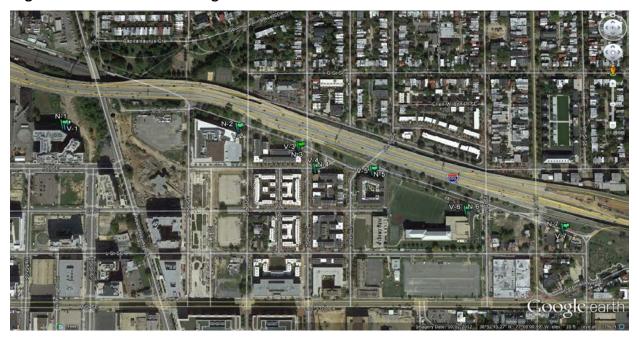
Figure 1. Vibration Monitoring Locations

Construction vibration level data was collected for the reporting period starting August 1 through August 31, 2016. Eight fixed vibration monitoring locations have been measured continuously to monitor vibration levels since the beginning of major construction activities in May 2015. Vibration level data was collected every minute for the duration of the vibration monitoring period. The locations of the monitoring stations are depicted in Figure 1 and the addresses described in Table 1.

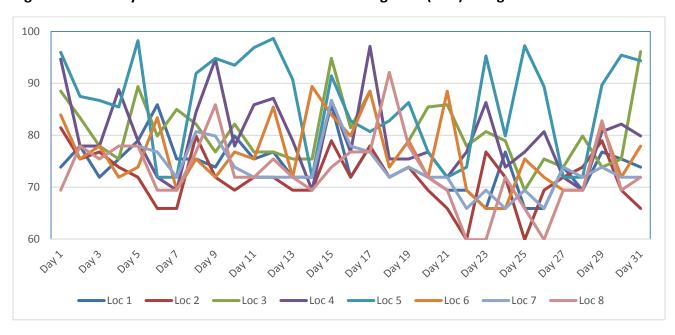
Figure 2. Summary of Construction Vibration Monitoring Data (VdB) - August 2016

Table 2 presents the results of the maximum vibration levels measured during the month of August 2016 and show how the measured levels compare to the established vibration criteria. The average daily vibration level results are plotted in Figure 2. An exceedance of the vibration criteria was recorded during construction at Locations 4 and 5. However, the rate of occurrence (three and seven time during the month at each location respectively) and the short duration of the event (less than 3 seconds for each event) is not expected to cause damage to any of the nearby structures at either location. [Note that Location 7 did not record data on August 1, 2, 3 and 4 due power losses and equipment maintenances caused by severe thunderstorms. A similar situation occurred at Location 3 on August 18.]
